Best Practice Catalog

Draft Tube Gates

Revision 1.0, 12/08/2011

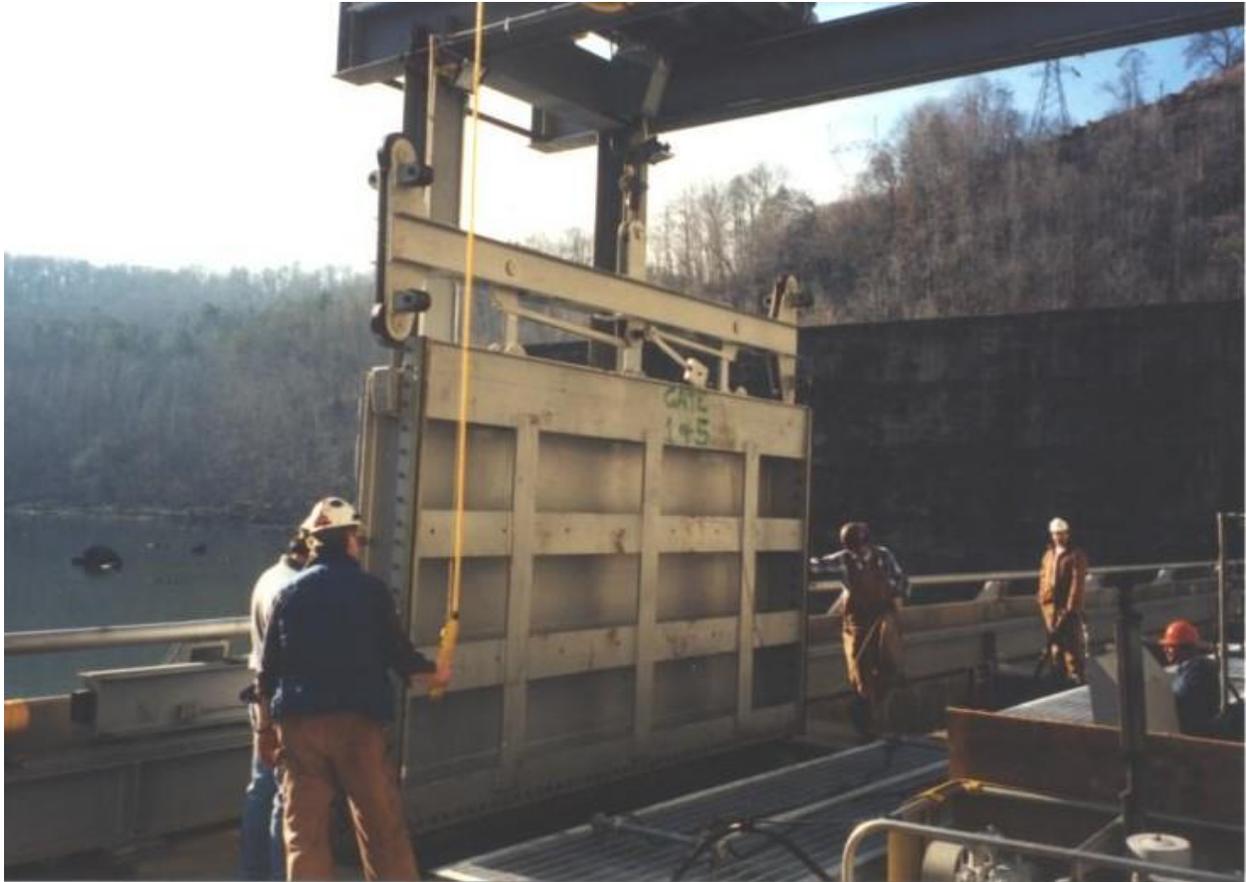
Figure 1: Norris Dam – Anderson/Campbell County, TN

The Norris hydro plant had been in operation for nearly 60 years without dewatering equipment for the draft tubes. But modernization of the plant could not be accomplished without dewatering. Shown in Figure 1 is the initial installation of one of the new draft tube gates supported by the overhead traveling gantry crane connected by the lifting beam. The overhead gantry and crane rail girder is shown in Figure 2 while undergoing load testing. Other system components included in the design but not shown are the dewatering pumps, draft tube gate guides, and seal bearing plates.

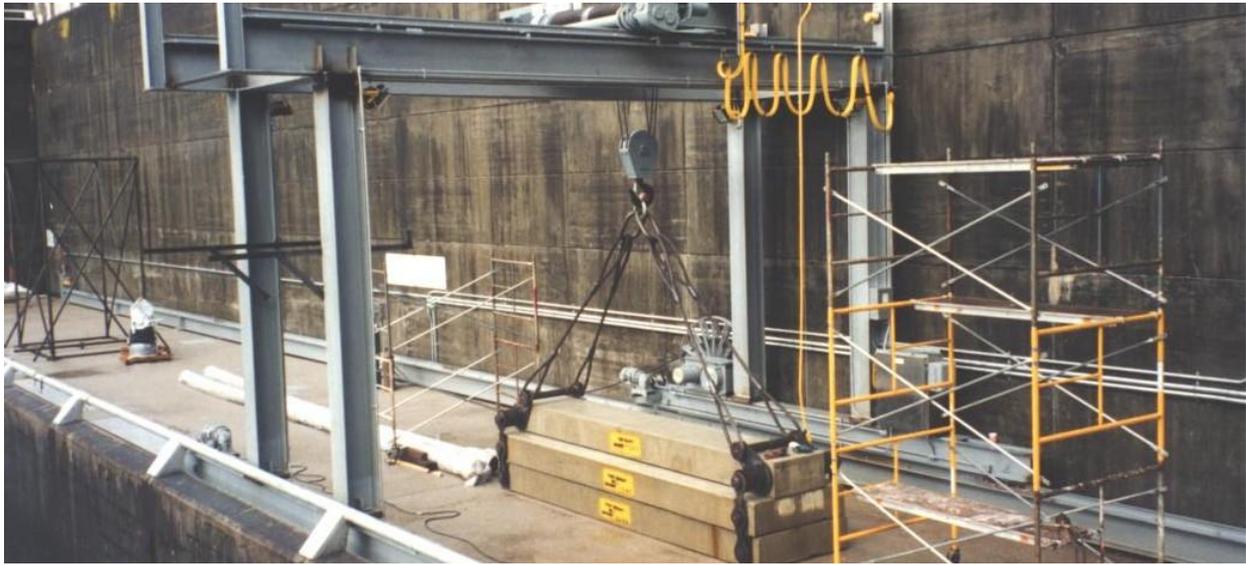
Figure 2: Norris Dam – Anderson/Campbell County, TN

Difficulties have been experienced while lifting the draft tube gate without a lifting beam. The design above includes the lifting beam, new crane hook, hook lift points on the gate and gate dogging device for supporting the gate when not being utilized.
