# **Best Practice Catalog**

## *Francis Turbine*

Revision 1.0, 12/06/2011

MESA ASSOCIATES, INC.  
Chattanooga, TN 37402

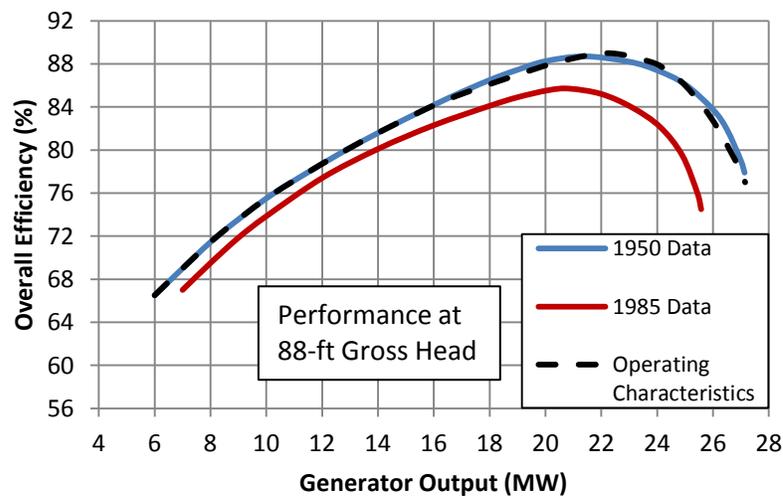
Figure 1: Example - Original vs. Degraded Performance Curves [8]

Turbine efficiency is likely the most important factor in an assessment to determine rehabilitation or replacement. Such testing may show CPL has degraded significantly from IPL. Figure 1 is an example of the peak efficiency of a Francis unit with a percentage point drop in peak efficiency of greater than 3 in a 35 year period since it went into commercial operation. Regardless of whether performance has degraded or not, newer turbine designs are usually more efficient than those designed 30 to 40 years ago. Also, a new turbine can be designed using actual historical operations rather than original design data providing a turbine more accurately suited for the site.

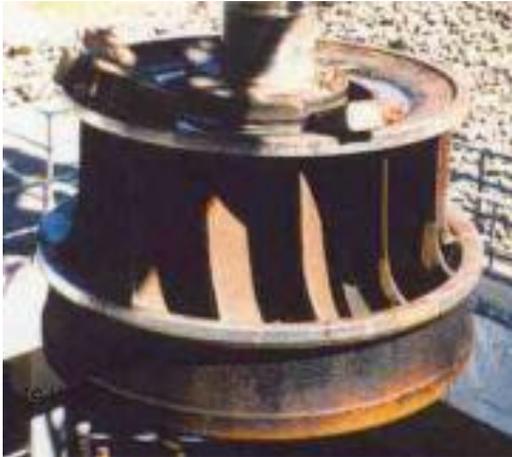
**Figure 2: Original Runner**

Newer state of the art turbine designs can not only achieve the PPL but also provide decreased cavitation damage based on better hydraulic design and materials [3]. Figures 2 and 3 show an original runner and its state of the art stainless steel replacement runner, as a comparison. Figure 6 shows a state of the art aerating runner which discharges the air from the bucket tips.

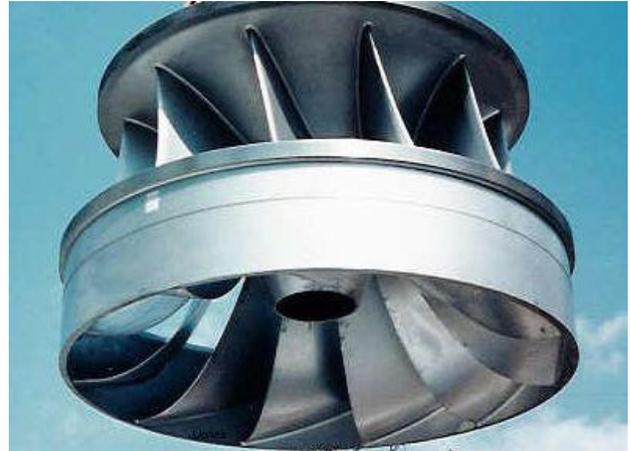
**Figure 3: New Stainless Steel Replacement Runner**

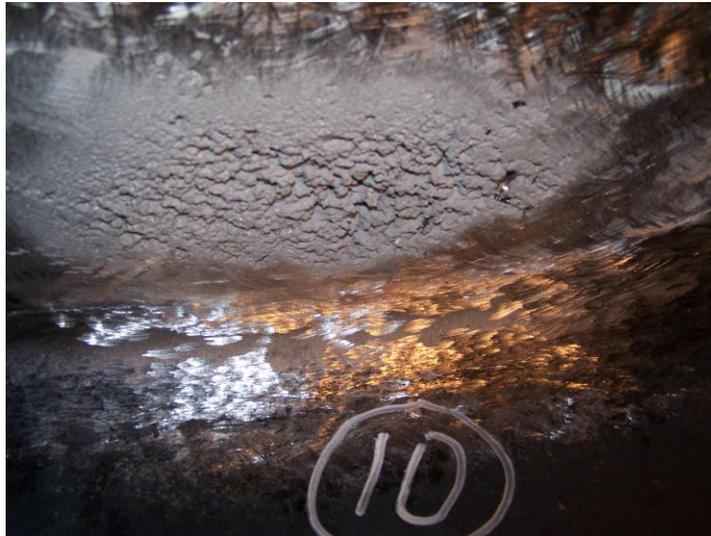
**Figure 4: Typical Cavitation Damage to Runner Blade**

Condition assessment of those flow components must address any past damage, location of damage, repeat damage, and resulting increase in surface roughness. Evaluating the overall condition of a turbine and all its components may show that a new state of the art turbine runner with enhanced power and efficiency may provide sufficient benefits to justify its

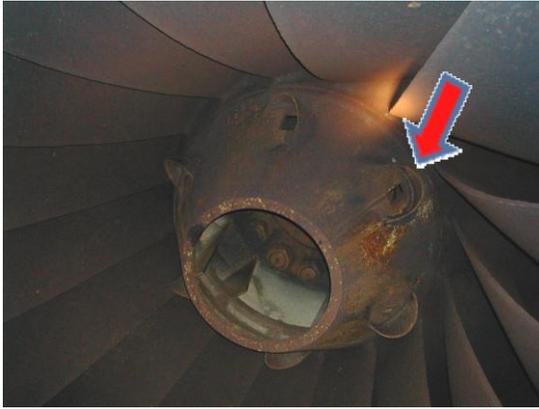
**Figure 5: Aeration Baffles on Nose Cone**

Aeration devices for the turbine can take the form of more complex active systems, such as motorized blowers, to the less complex passive systems, such as baffles and self aspirating runner designs. The passive designs are being the most common practices, as shown in Figures 5 and 6.

Focusing on the most common designs, the condition assessment would include inspections of the air discharge passages in the turbine and any observable cavitation or erosion damage that might affect its normal operation. A decrease of normal dissolve oxygen uptake in the waterway downstream could be an indicator of degradation of the condition of the aeration device.

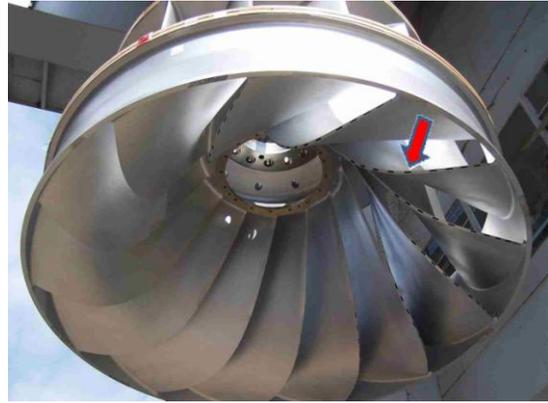
**Figure 6: Aerating Runner (through bucket tips)**

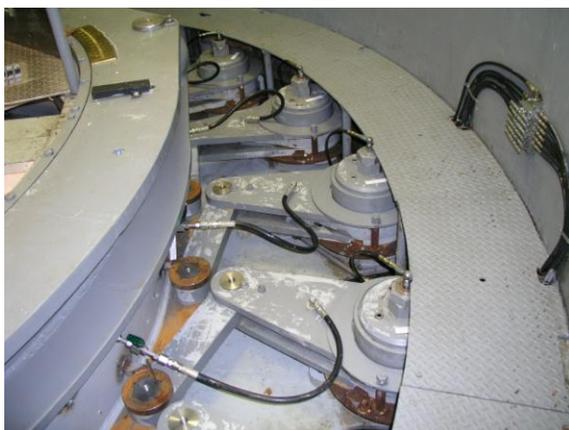
**Figure 7: Wicket Gate Mechanism**

The wicket gate mechanism (Figure 7) and the actuating servomotors provide for the regulation and control of the turbine. The condition assessment of the components would include measurements of wear or looseness in the arms, linkages, pins, shear pins, turnbuckles (or eccentric pins), linkage bushings, operating ring (and bearing pads), and wicket gate stem bushings. It is important to note, that excessive wear in the components is additive and can result in losing off-line regulating control of the wicket gates making it more difficult to synchronize the unit. This is an indicator that rehabilitation on the components is necessary. Measurement of wear is difficult without disassembly, however, extreme wear can be observed as loss of motion in gate movements.

In some turbine designs it is possible during un-watered outages, to measure the clearance between the wicket gate stem journals and the inside diameter of the bushings with feeler gauges. Abnormal water leakage around the wicket gates in the turbine wheel pit after an attempt to adjust the stem packing is an indicator of excessive wicket gate stem bushing wear. As a best practice, bushing to journal clearance greater than two times the design is considered excessive. An increase in the number of shear pin failures over a given period is an indication of either a problem with the design and material used to manufacture the pins or a problem with binding in the mechanism.

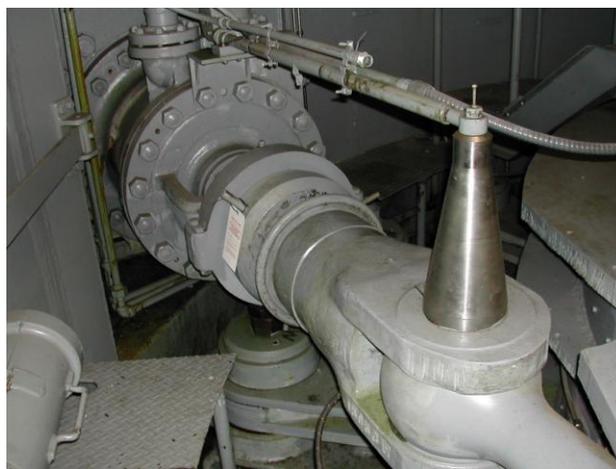
**Figure 8: Wicket Gate Servomotor**

Hydraulic servomotors (Figure 8) are usually very reliable, with the most common problem being oil leakage from the seal on the actuating rod. The amount of acceptable leakage is dependent on the seal design and site maintenance requirements. Hydraulic seals will leak very little whereas a square braided compression packing will leak more. A condition assessment would include observation of the leakage and discussion with the plant maintenance technicians as to the amount of daily or weekly maintenance required. Excessive maintenance would require the change of the seal or packing. It is important to note and observe if the actuating rod is smooth, without any scoring or grooves which would prevent sealing. If the rod is damaged it will require repair or replacement.

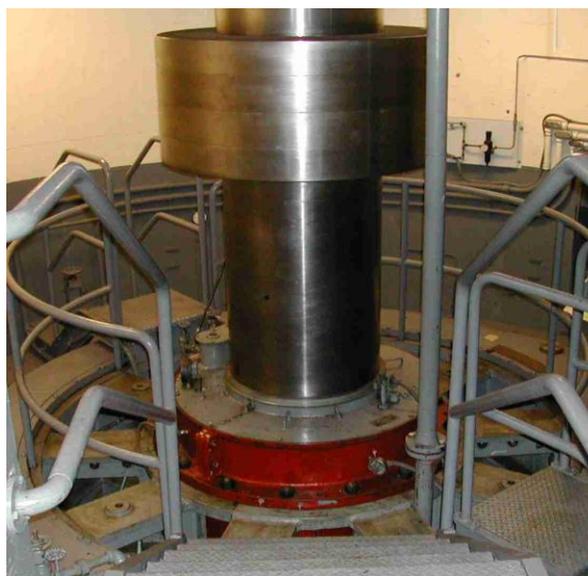
**Figure 9: Turbine Shaft / Wheel Pit**

The condition assessment of the turbine shaft (Figure 9) would include observation of corrosion and defects on the exposed surface. Any cracking as identified by the Nondestructive Examination (NDE) methods is a major concern and must be addressed immediately.

Bearing journals and sleeves must be smooth and free of defects (only accessible with bearing removed) to ensure the reliability of the turbine guide bearing. As a best practice for water lubrication turbine bearings, wearing sleeves are usually manufactured from ASTM A487 / A743 CA6NM stainless steel either as a forging or centrifugally cast [18, 19]. Areas near the shaft seal that are exposed to water should be sealed with a robust coating such as an epoxy paint to prevent corrosion of the shaft.

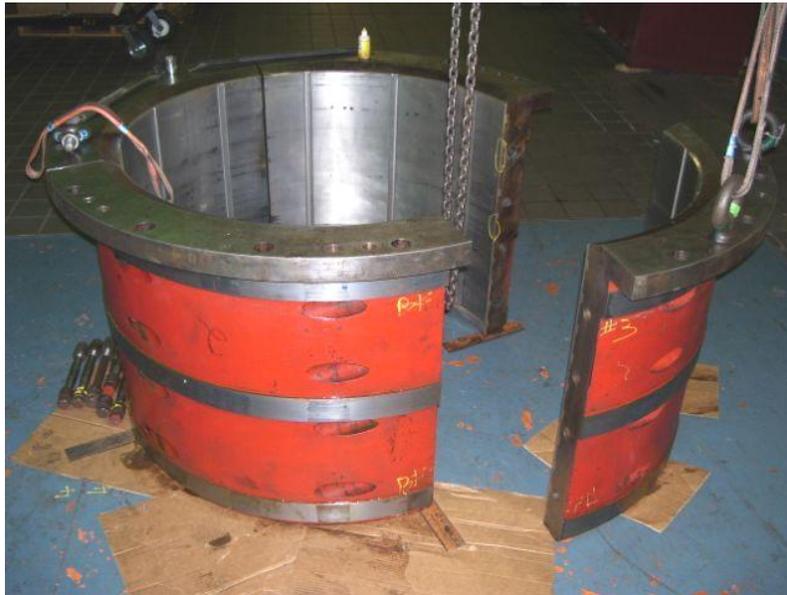
**Figure 10: Babbitted Oil Journal Bearing**

Turbine guide bearings are usually either oil lubricated hydrodynamic bearings (Figure 10) or water lubricated bearings (Figure 11), with the latter being found only in low head slow speed units. The condition assessment of the oil lubricated type includes vibration measurements (i.e. shaft throw) and temperature of the bearing in operation. Abnormal indications of those could be a sign of failure of the babbitted surface (wipe), un-bonding of the babbitt from the bearing housing, or contamination of the oil. The condition assessment of a water lubricated type centers mainly on vibration measurements and success of subsequent bearing adjustments if the design permits. An indication of a loose wearing sleeve on the shaft is excessive shaft throw (vibration) even after adjusting the bearing. Non-adjustable water lubricated bearings, or bearings worn beyond adjustment will require the wearing liner (either wood, plastic, or composite) to be replaced.

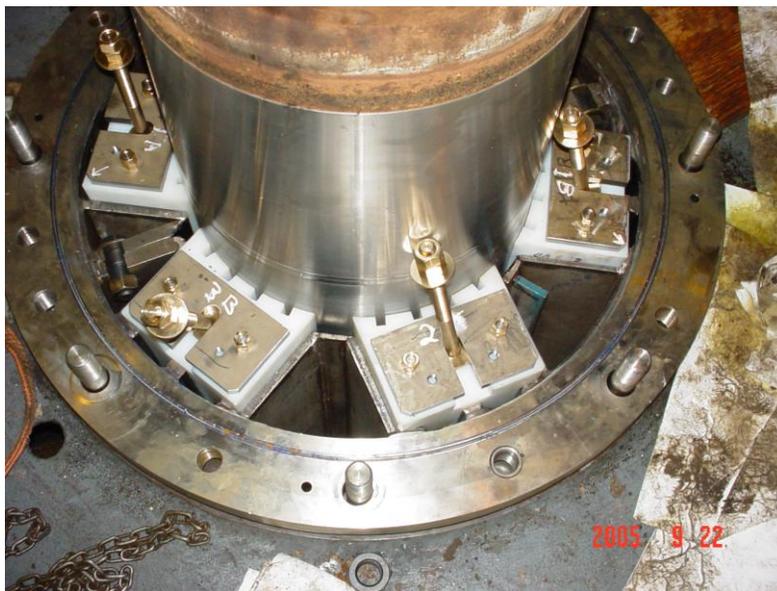
**Figure 11: Water Lubricated Bearing**

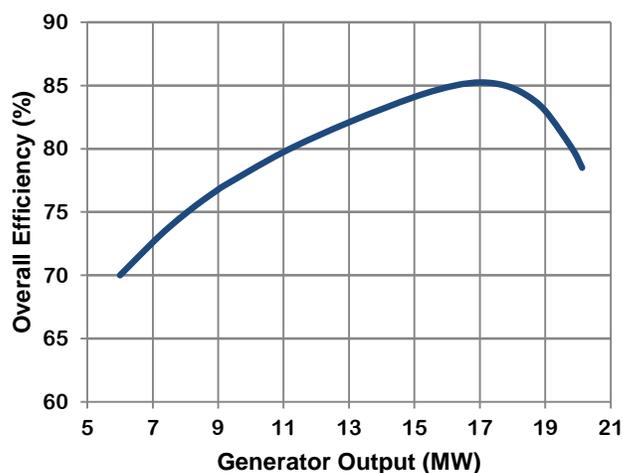
**Figure 12: Typical Francis Performance Curve**

Since Francis turbines have a very narrow operating range for peak efficiency (Figure 12), it is extremely important for plant operations to have an accurate operating curve for the units. The curves originate from the manufacturer's model test data and post installation performance testing. The performance of the turbine can degrade over time, due to cavitation and/or erosion damage and resulting weld repairs, etc. Therefore, to maximize unit efficiency, periodic performance testing, either as absolute or relative testing must be carried out to update operational performance curves. An example of relative testing would be index testing (using Winter Kennedy taps).

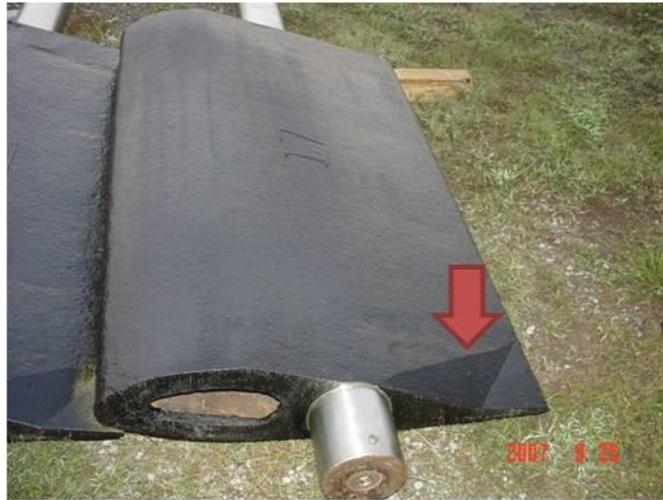
**Figure 13: Wicket Gate Modification**

In some cases, Von Karman vortices can trail off the wicket gates during high flow operation, impinging on the runner band and blades with resulting cavitation damage. Flow profile modifications, including a narrowing of the lower trailing edges (as shown in Figure 13) of the wicket gates, can reduce the formation of vortices, and thus allow higher flow rates and power output. The exact profile change should be designed based on CFD and/or physical modeling.
