Best Practice Catalog

Draft Tube Gates

Revision 2.0, 8/01/2011

MESA ASSOCIATES, INC.
Chattanooga, TN 37402

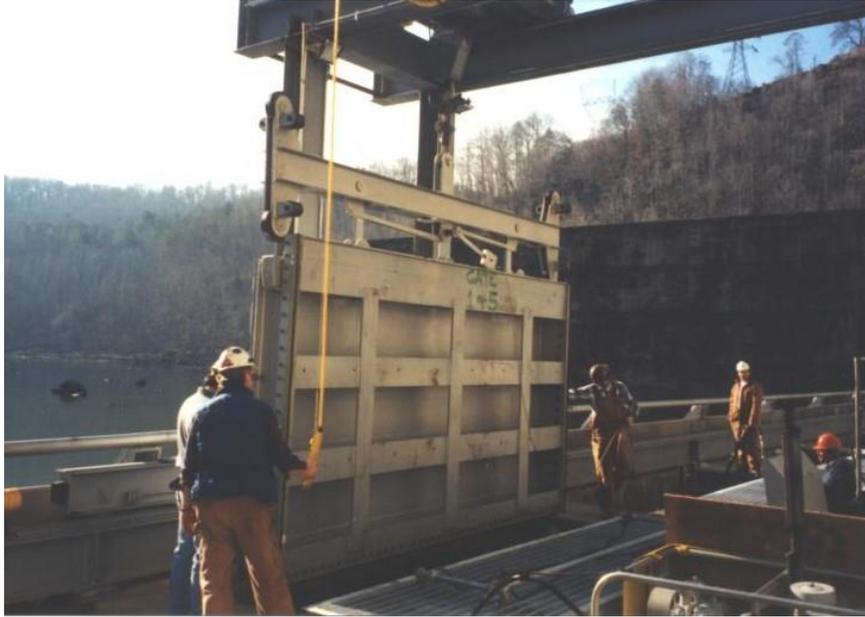
Figure 1: Norris Dam – Anderson/Campbell County, TN

The Norris hydro plant had been in operation for nearly 60 years without dewatering equipment for the draft tubes. But modernization of the plant could not be accomplished without dewatering. Shown in Figure 1 is the initial installation of one of the new draft tube gates supported by the overhead traveling gantry crane connected by the lifting beam. The overhead gantry and crane rail girder is shown in Figure 2 while undergoing load testing. Other system components included in the design but not shown are the dewatering pumps, draft tube gate guides, and seal bearing plates.

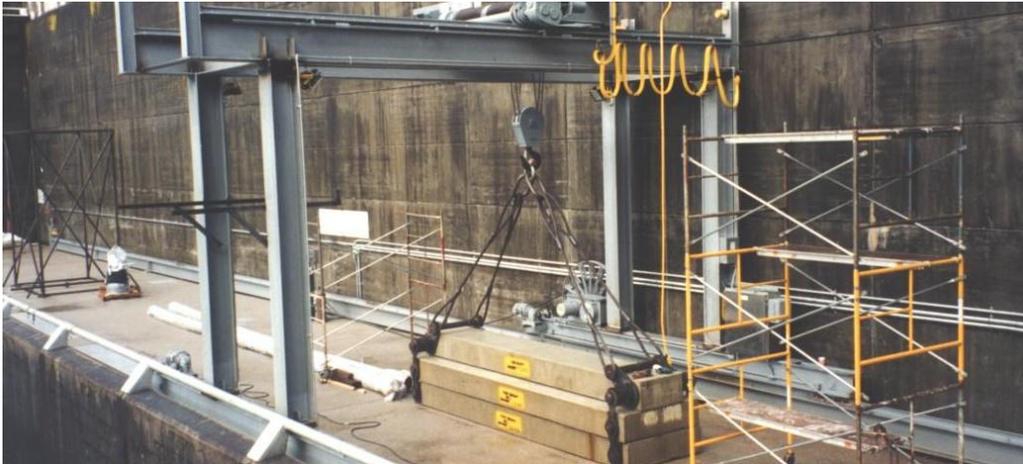
Figure 2: Norris Dam – Anderson/Campbell County, TN

Difficulties have been experienced while lifting draft tube gates with a height to width aspect ratio of less than 1.0 from a central lift point. Gates of this configuration have an increased potential to tilt and bind in the gate slots while lifting. Providing two lift points one at each end of the gate or using a lifting frame assembly can alleviate this issue. The lifting assembly above includes a lifting beam, crane hook, hook lift points on the gate, and a gate dogging device for supporting the gate when not being utilized.

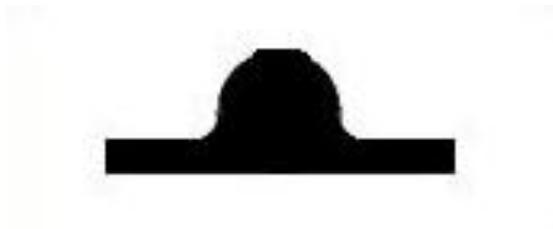
Figure 3: Solid Double Stem Seal

The primary technological advances for draft tube gates are in the areas of the seals and corrosion protection of the steel. Seal geometry and means of attachment to the gate can be selected so that the seal is not susceptible to being rolled over due to the velocity of the water past the seal, or due to wedging of debris between the seal and the sealing surface. The double stem top seal, shown in Figure 3, is highly desirable due to its geometrical stability and ability to resist rolling over due to water velocity past the seal. Concrete and steel surfaces must be smooth, burr and rust free to prevent wear and damage to the seals. For steel sealing surfaces, a stainless steel overlay or cladding can be utilized to provide the seal with an unpitted and rust free sliding surface. An important advancement in draft tube gate design and fabrication in the past 40 years has been the use of rubber gate seals with a J-bulb or music note shape (See Figure 4). This advanced seal design allows for movement by using adjustable mounting attachments.

Inadequate maintenance of seals and hoisting mechanisms can lead to several problems such as seal damage/rolling, unequal hoisting chain length and loading, and motor overload. When a gate is being lifted, seals can roll over and wedge the gate between the sealing surfaces, thereby damaging the seal and increasing the lifting loads to be overcome by the hoist. The corrective action involves replacing the gate seals and redesigning the means used to attach the seal to the gate, or using reconfigured seal geometry. Most seals at today's hydropower plants are made of rubber and can become worn or damaged over extended time periods of use. Worn or damaged seals can cause excessive leakage which results not only in loss of water, but can also lead to erosion of the concrete surfaces. Replacing the seals with the current bulb type, which are adjustable, provides more allowance for movement in the seal and provides capability to resist water pressures from either side. If excessive seal to guide friction is causing problems, this can be mitigated by providing fluorocarbon cladding to the seal bulb. J-bulb seals work best when allowed to deflect rather than compressing the bulb against the sealing surface.
