Best Practice Catalog

Propeller/Kaplan Turbine

Revision 1.0, 12/06/2011

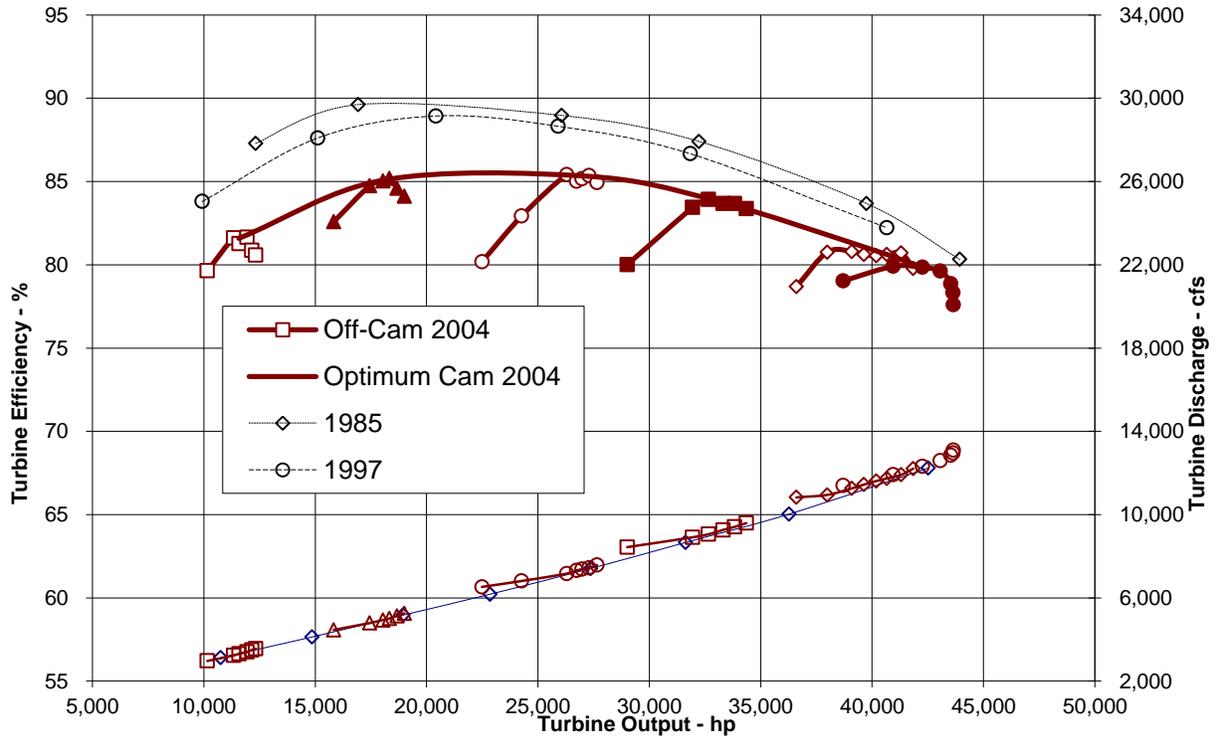
Figure 1: Kaplan Performance Degradation

Turbine efficiency is likely the most important factor in a condition assessment to determine rehabilitation or replacement. Testing may show performance has degraded significantly. For example the efficiency of a Kaplan unit has experienced steady degradation amounting to a total of 4 percentage points over a 19 year period (Figure 1).

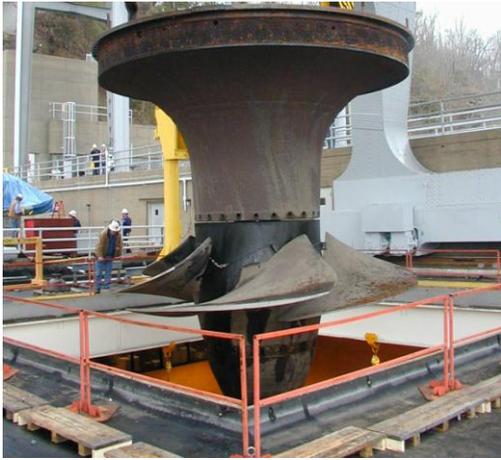
Figure 2: Original Runner

Regardless of whether performance has degraded or not, newer turbine designs are usually more efficient than those designed 30 to 40 years ago. Also, a new turbine can be designed using actual historical data rather than original design data providing a turbine more accurately suited for the site. Newer turbine designs also provide decreased cavitation based on better hydraulic design and materials [2]. For comparison, Figures 2 and 3 show an original runner and its stainless steel replacement runner.

Typically, Kaplan runner blades are designed with stress relief grooves at the leading and trailing sides of the blade/trunnion intersection (Figure 13). These grooves, located to minimize the possibility of cracking in the high stress areas of the blade, create cavities in the flow profile which cause downstream disturbances in the form of low pressure vortices and can result in cavitation erosion on the hub and nose cone. It has been shown that fillers, attached to the blade or trunnion seal, have been effective in reducing the erosion, especially when paired with strategically-located stainless steel overlay on the hub and nose cone. Figure 14 shows a typical overlay area for a Kaplan runner hub/nose cone. Also, the spherical design of some newer runner hubs, as opposed to the traditional conical design, minimizes the gap between the blades and hub as the blades move to flatter positions (Figures 2 and 3).

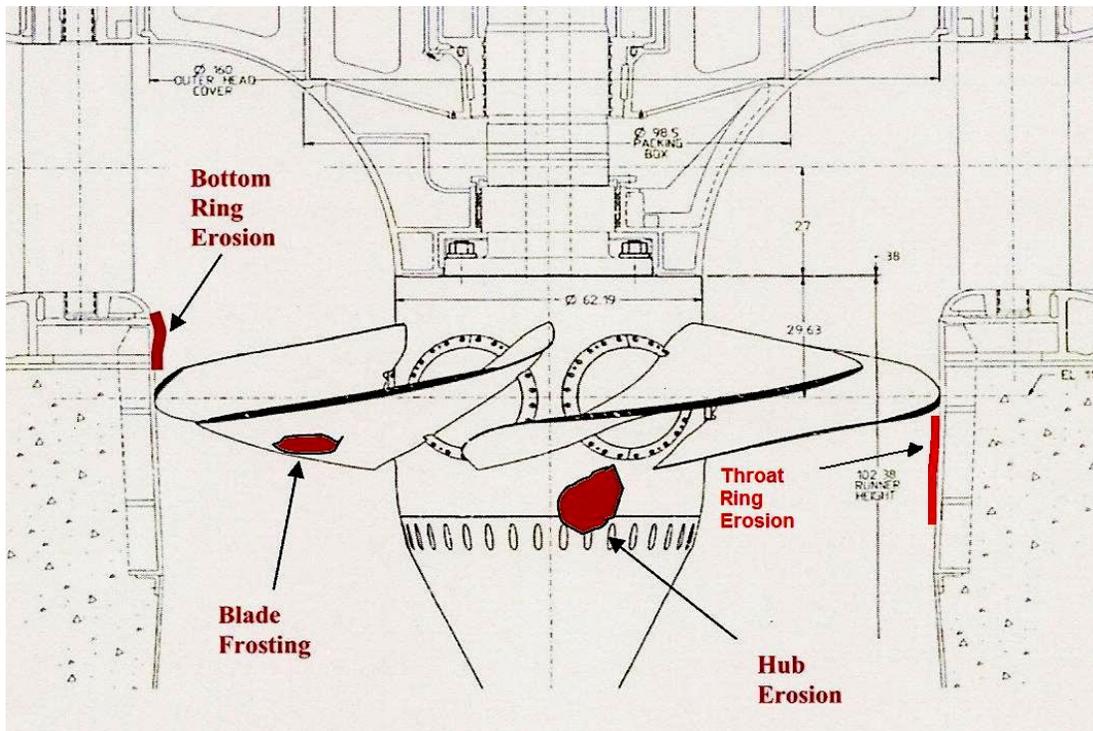
Figure 4: Typical Areas to Check for Cavitation Damage

The other wetted turbine components such as stay vanes, spiral cases, and draft tubes are usually constructed from steel due to strength requirements. Some components have stainless steel cladding overlaid in critical areas. The most significant contributor to performance loss for all wetted components is any metal loss due to cavitation, as shown

in Figure 4, abrasive erosion, surface finish degradation, and the poor quality of past repairs which can distort the hydraulic design contours of components.

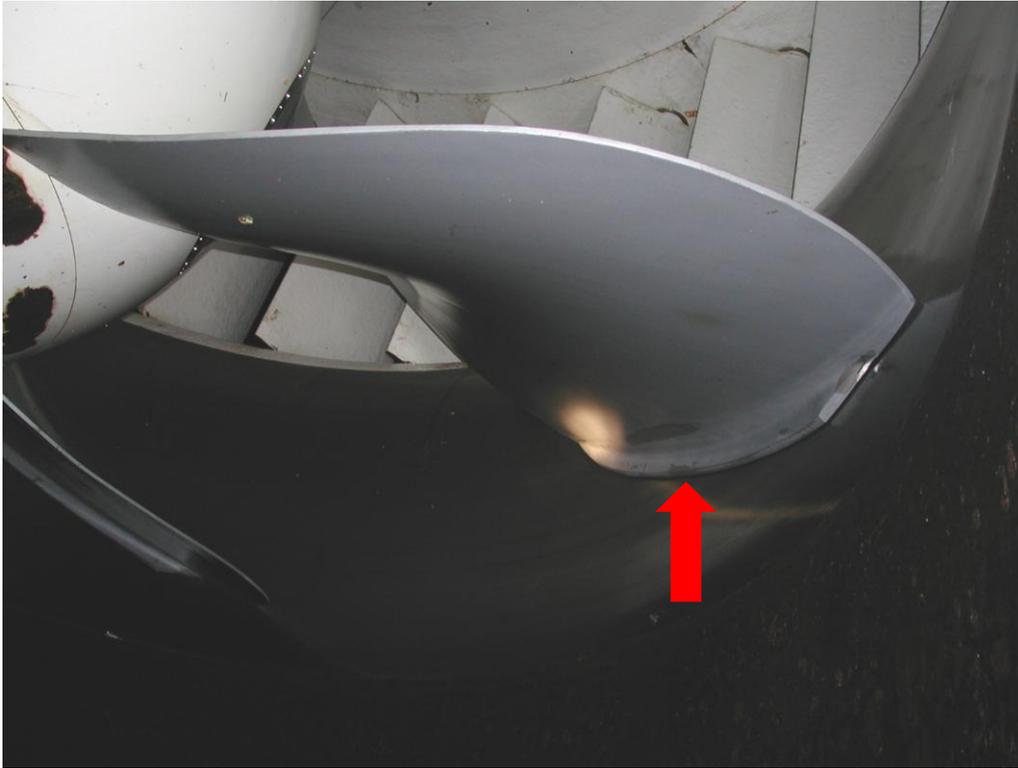
Figure 5: Anti-Cavitation Fin & Throat Ring Overlay

A certain amount of cavitation is inherent in a Kaplan runner, primarily due to gaps between the blade inner periphery and hub, and between the blade outer periphery and throat ring. Most runners manufactured since the 1980's include an “anti-cavitation fin” (located on a portion of the suction side of the blade outer periphery) to serve as a sacrificial element (Figure 5). Periodic inspection of this fin and of the throat ring may assist in identification of excessive operation beyond recommended cavitation limits in an effort to take advantage of the excessive flow and/or head which are otherwise wasted.

Additional areas for stainless steel overlay include the throat ring to protect against “seal cavitation” at the blade periphery (Figure 5), and sections of the lower distributor ring and bottom ring where Von Karman vortices can trail off the wicket gates during high flow operation (Figure 15).

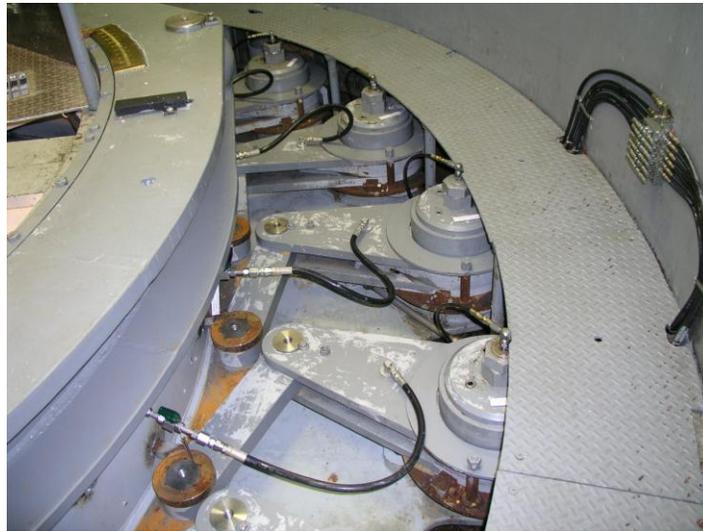
Figure 6: Wicket Gate Mechanism

The wicket gate mechanism (Figure 6) and the actuating servomotors provide for the regulation and control of the turbine. The condition assessment of the components would include measurements of wear or looseness in the arms, linkages, pins, shear pins, turnbuckles (or eccentric pins), linkage bushings, operating ring (and bearing pads), and wicket gate stem bushings. It is important to note, that excessive wear in the components

is additive and can result in losing off-line regulating control of the wicket gates making it more difficult to synchronize the unit. This is an indicator that rehabilitation on the components is necessary. Measurement of wear is difficult without disassembly, however, extreme wear can be observed as loss of motion in gate movements.

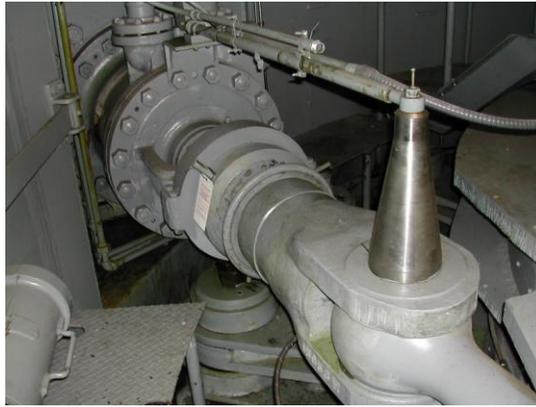
Figure 7: Wicket Gate Servomotor

Hydraulic servomotors (Figure 7) are usually very reliable, with the most common problem being oil leakage from the seal on the actuating rod. The amount of acceptable leakage is dependent on the seal design and site maintenance requirements. Hydraulic seals will leak very little whereas a square braided compression packing will leak more.

A condition assessment would include observation of the leakage and discussion with the plant maintenance technicians as to the amount of daily or weekly maintenance required. Excessive maintenance would require the change of the seal or packing. It is important to note and observe if the actuating rod is smooth, without any scoring or grooves which would prevent sealing. If the rod is damaged it will require repair or replacement.

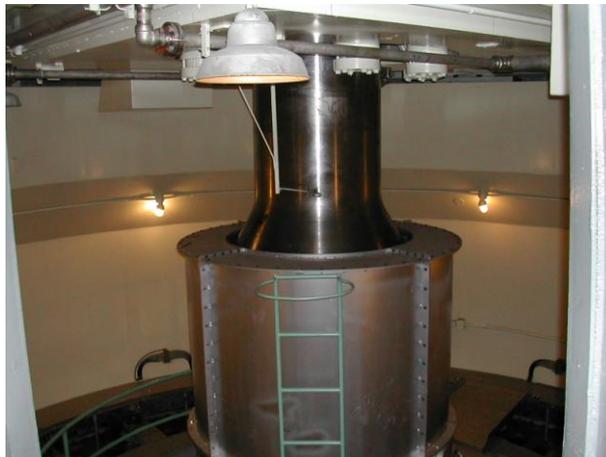
Figure 8: Turbine Shaft / Wheel Pit

The condition assessment of the turbine shaft (Figure 8) would include observation of corrosion and defects on the exposed surface. Any cracking as identified by the Nondestructive Examination (NDE) methods is a major concern and must be addressed immediately. Bearing journals and sleeves must be smooth and free of defects (only accessible with bearing removed) to ensure the reliability of the turbine guide bearing. As a best practice for water lubrication, turbine bearings, wearing sleeves are usually manufactured from ASTM A743 CA6NM [17] stainless steel either as a forging or centrifugally cast. Areas near the shaft seal that are exposed to water should be sealed with a robust coating such as an epoxy paint to prevent corrosion of the shaft.

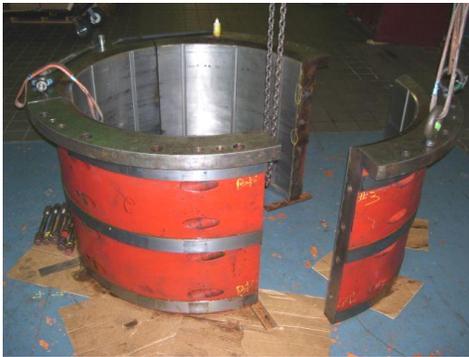
Figure 9: Babbitted Oil Journal Bearing

Turbine guide bearings are usually either oil lubricated hydrodynamic bearings (Figure 9) or water lubricated bearings (Figure 10), with the latter being found only in low head slow speed units. The condition assessment of the oil lubricated type includes vibration measurements (i.e. shaft throw) and temperature of the bearing in operation. Abnormal indications of those could be a sign of failure of the babbitted surface (wipe), un-bonding of the babbitt from the bearing housing, or contamination of the oil.

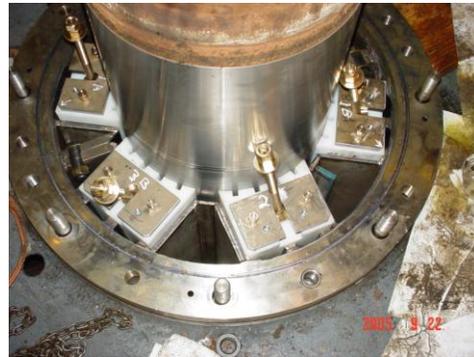
Figure 10: Water Lubricated Bearing

The condition assessment of a water lubricated type, centers mainly on vibration measurements and success of subsequent bearing adjustments (design permitting). An indication of a loose wearing sleeve on the shaft is excessive shaft throw (vibration) even after adjusting the bearing. Non-adjustable water lubricated bearings, or bearings worn beyond adjustment will require the wearing liner (either wood, plastic, or composite) to be replaced.

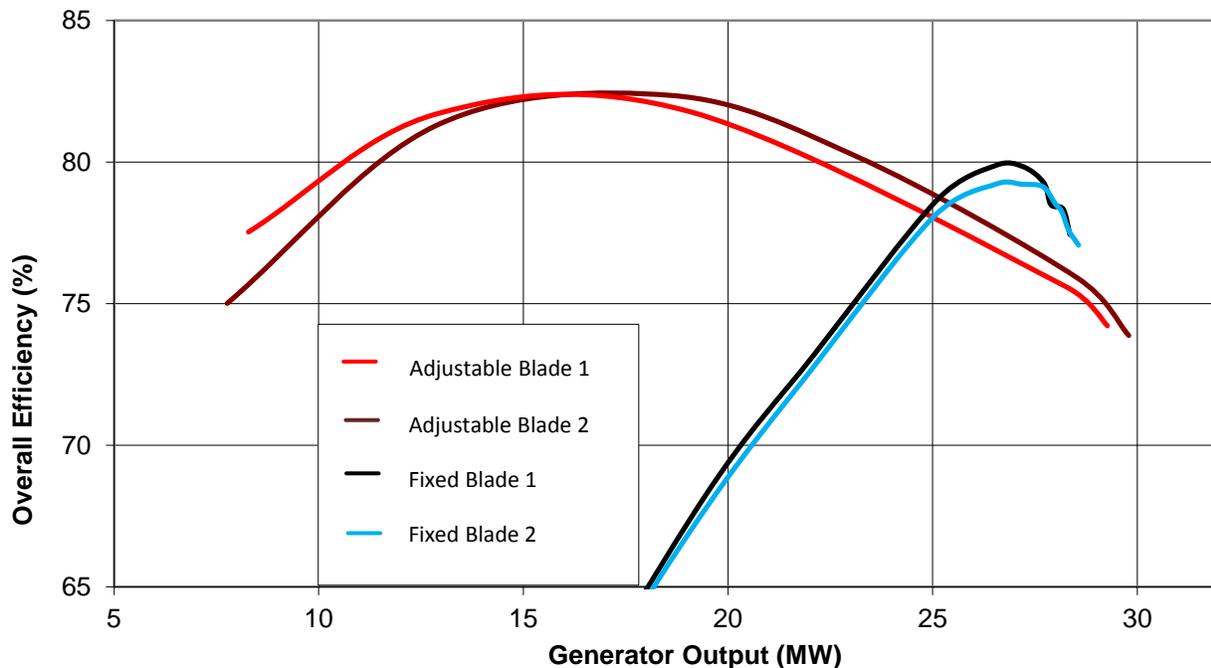
Figure 11: Typical Fixed and Adjustable-Blade Unit Efficiency Curves

Figure 11 shows typical performance curves for fixed and adjustable-blade units (in this case, from the same plant). The very narrow range of high efficiency in the fixed blade units must be defined accurately to optimize performance. In contrast, the adjustable-blade units offer a much wider range of high efficiency; however, the absolute peaks of the individual blade tilt efficiency curves (Figure 1) must be defined accurately in order to develop the optimum gate-blade relationships required to realize optimum performance.

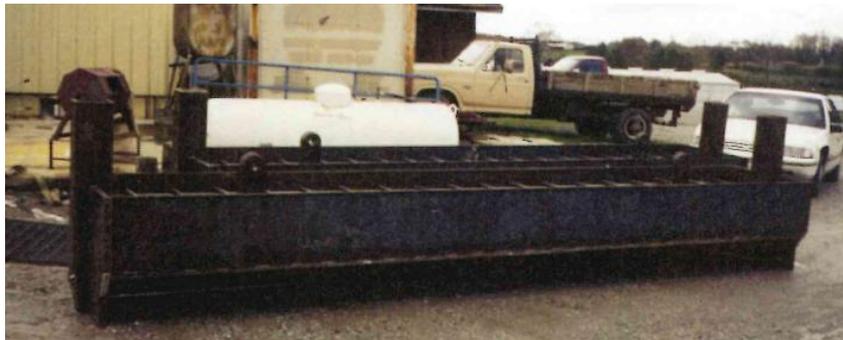
Figure 12: Draft Tube Gate Slot Fillers

Pressures in the draft tube increase as the water flows from the elbow to the exit. If the top of the draft tube gate slots are submerged (under tailwater), water can be drawn down into the draft tube due to the lower pressure there, increasing the total flow in the draft tube from that point to the exit, thereby increasing the head loss and reducing the unit efficiency. The closer the gate slot is to the centerline of the unit, the greater the effect. The use of slot fillers to plug the upper openings of the gate slots (Figure 12) have been shown to remedy this problem in one case by as much as 1% efficiency [7].

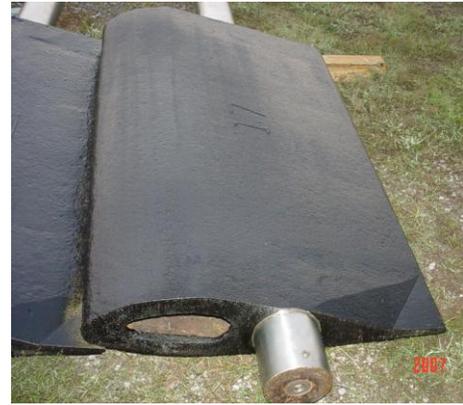
Figure 16: Modified Wicket Gate

Flow profile modifications, a narrowing of the lower trailing edges of the wicket gates (Figure 16), can reduce vortices and allow higher flow rates and power output. The exact profile change should be designed based on Computational Fluid Dynamics (CFD) and/or physical modeling.

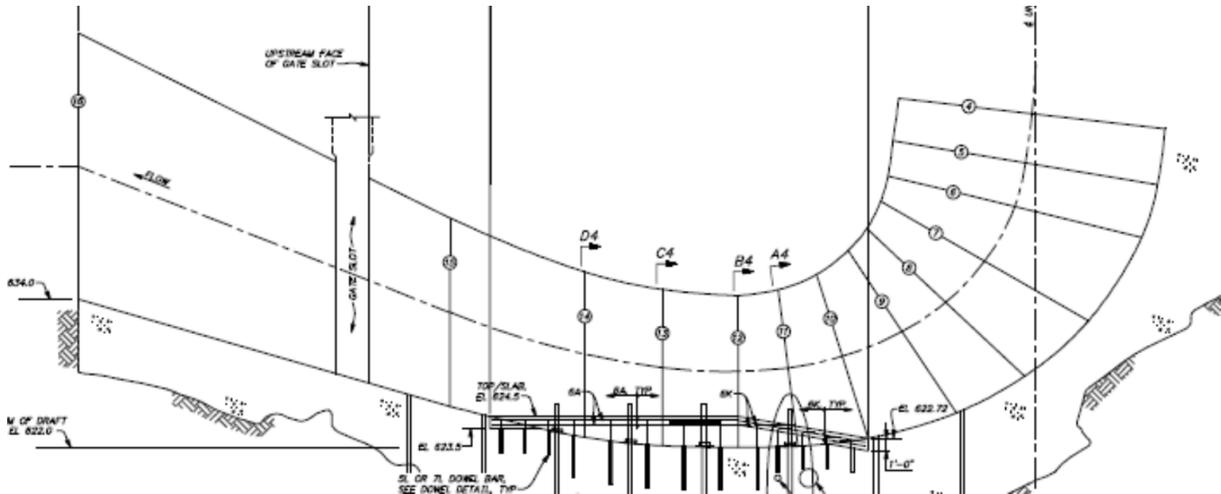
Figure 17: Draft Tube Modification

At certain head and flow rate combinations, flow separation can occur in the elbow section of some draft tubes resulting in unstable operation (stall). This is manifested in scattered data forming steep, peaky efficiency curves for individual blade tilts which make it difficult to determine and maintain an optimum gate-blade relationship. A reduction in the cross-sectional area of the elbow can reduce separation and be accomplished economically by strategically pouring concrete to raise the floor elevation (Figures 17 and 18).

Exact pour locations and depths should be determined using CFD and/or physical modeling. The result is more rounded efficiency curves so that if the gate-blade relationship changes, the operation will shift only slightly lower in efficiency instead of nose-diving. Additionally, model tests for one project showed efficiency and capacity gains of 0.11% and 535 hp.
